# Service bulletin

THE BRITISH MOTOR CORPORATION (AUSTRALIA) PTY. LIMITED

## RADIATOR SIDE EXTENSION REINFORCEMENT

WOLSELEY  
24/80  
AUSTIN  
FREEWAY  
SEDAN  
AUSTIN  
FREEWAY  
STATION  
WAGON.

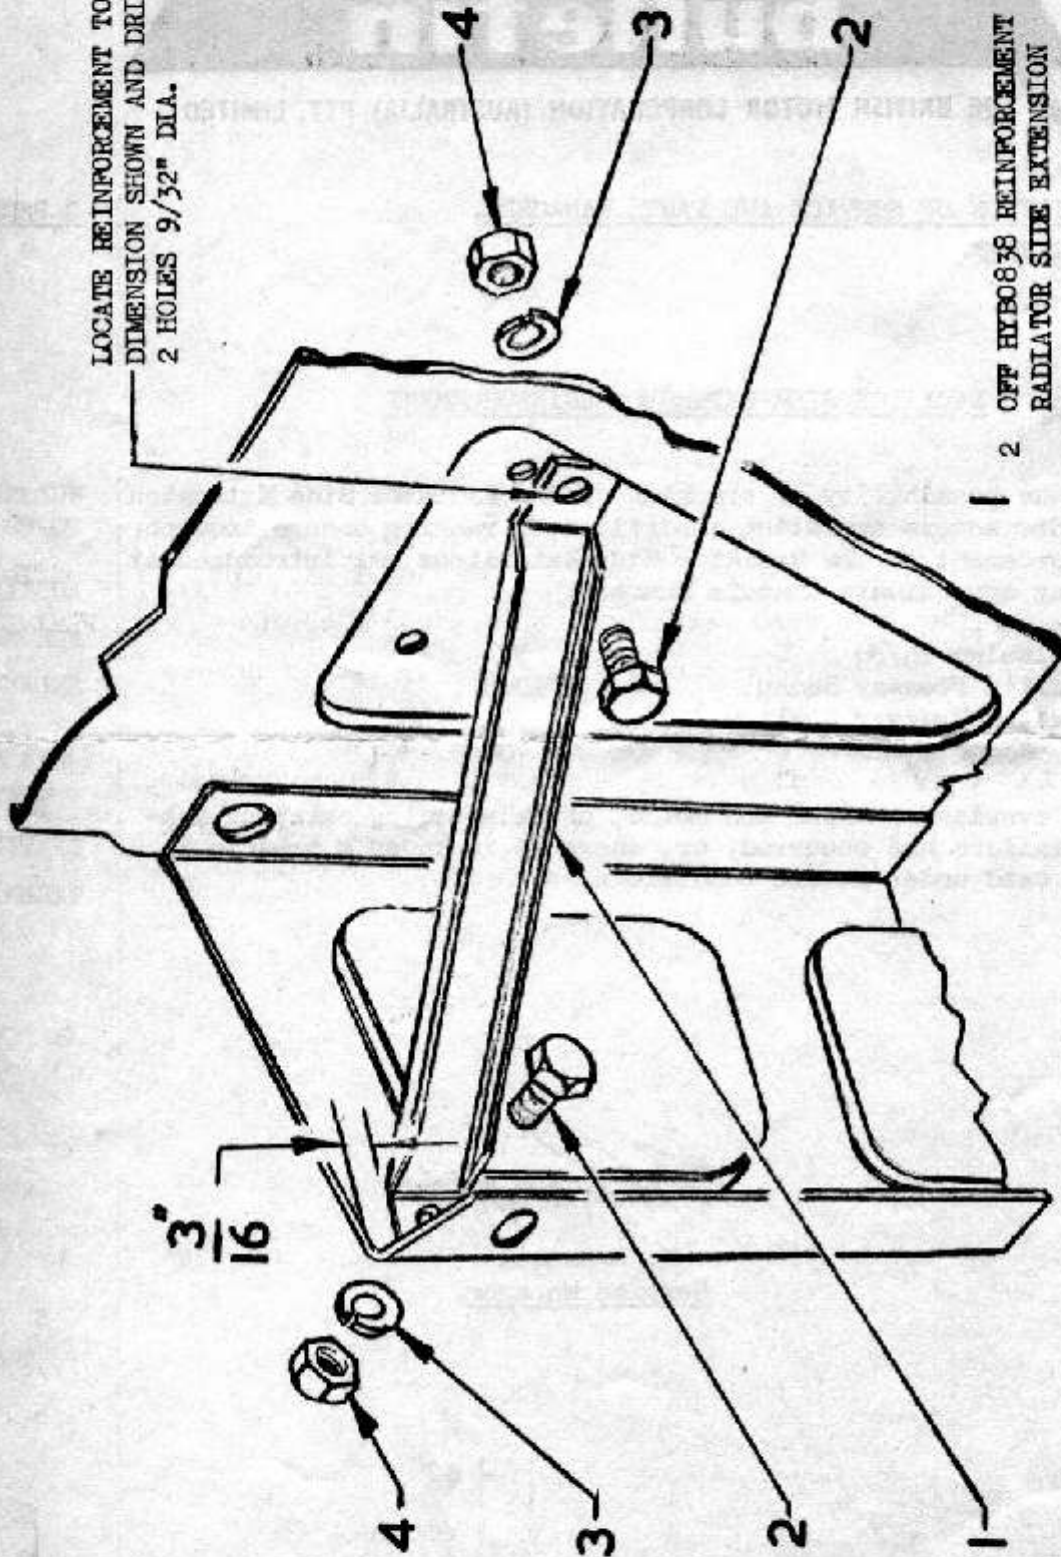
To prevent the possibility of cracking of the Radiator Side Extension Supports under severe operating conditions, a running change incorporating reinforcement to the Radiator Side Extensions was introduced at the following approximate Chassis Numbers:

The details overleaf outline the method of reinforcing existing vehicles if a failure has occurred, or, where it is known a vehicle is going to be used under severe conditions.

LOCATE REINFORCEMENT TO  
DIMENSION SHOWN AND DRILL  
2 HOLES 9/32" DIA.

- 1 2 OFF HYB0838 REINFORCEMENT  
RADIATOR SIDE EXTENSION
- 2 4 OFF HZS 0404 1/4" x 1/2" HEL.  
HD. SCREW.
- 3 4 OFF LWF 0204 SPRING WASHER
- 4 4 OFF FNZ 0504 1/4" HEL. NUT.
