Service bulletin

C. 207

THE BRITISH MOTOR CORPORATION (AUSTRALIA) PTY. LIMITED

ACCELERATOR PEDAL BENDING.

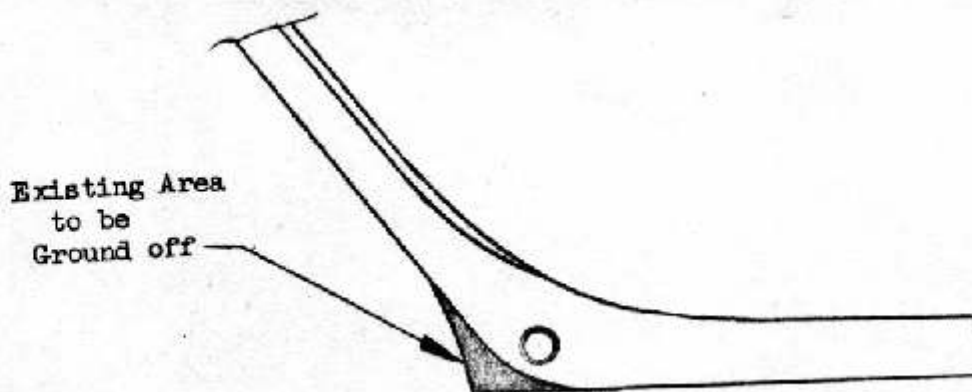
Hinge Joint of Pedal
showing hard corner

To prevent the Pedal from bending at hinge joint and also from bowing through the length when fully depressed - due to a hard corner of rubber under pivot point - a service modification is to grind away the hard corner and if sheet metal holding screw cannot be kept in position they should be replaced with machine screws, nuts and washers.
