Service bulletin

C. 247
Export
12

THE BRITISH MOTOR CORPORATION (AUSTRALIA) PTY. LIMITED

OIL LEAKAGE

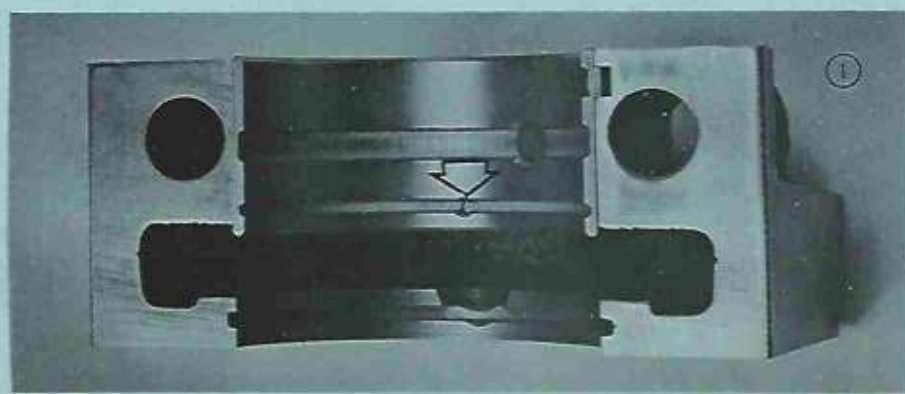
Diagram 1.
Grooved Bearing in Position

Grooved rear main bearing shells with an oil drain back in the lower half were introduced at the following engine numbers, Standard L14669, Automatic H4797 and Short Engine 1517. Rear main bearing caps may be reworked along the following lines.

1. Obtain a set of main bearing shells, Part No. HYL. 2825 (the rear bearing having a groove and oil drain hole).
2. Position the bottom shell in the bearing cap and mark out the drain hole with a scribe. Refer arrow diagram 1.
