Service bulletin

C
235
EXPORT
9

BRAKE PIPE POSITION

FREEWAY

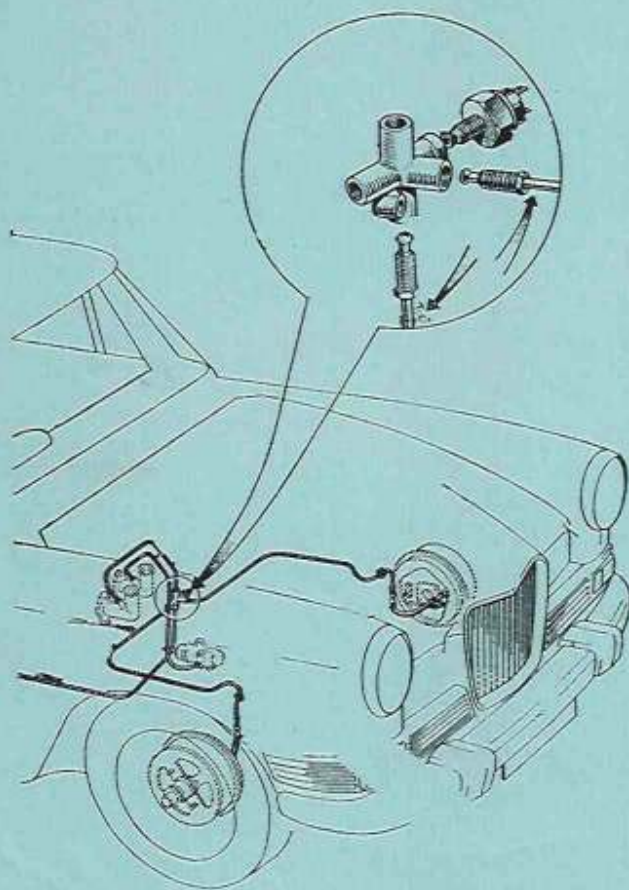
Instances have been reported of the brake pipe Part No. 1H215 positioned between the five way connection and L/H front brake hose lying too close to the rear of the engine. Also the brake pipe Part No. 1H5717 laying too close to the starter motor and gearbox mounting plate.

Arrows in sketch show pipes which may require attention.

Vehicles in Service should be examined immediately and if the clearance is not sufficient to stop chafing, the pipes should be repositioned by a slight pressure at suspect areas.
