# Service bulletin

C. 242  
EXP. 10

MUD PENETRATION - CONVERTER HOUSING

Wolseley  
24/80  
Automatic

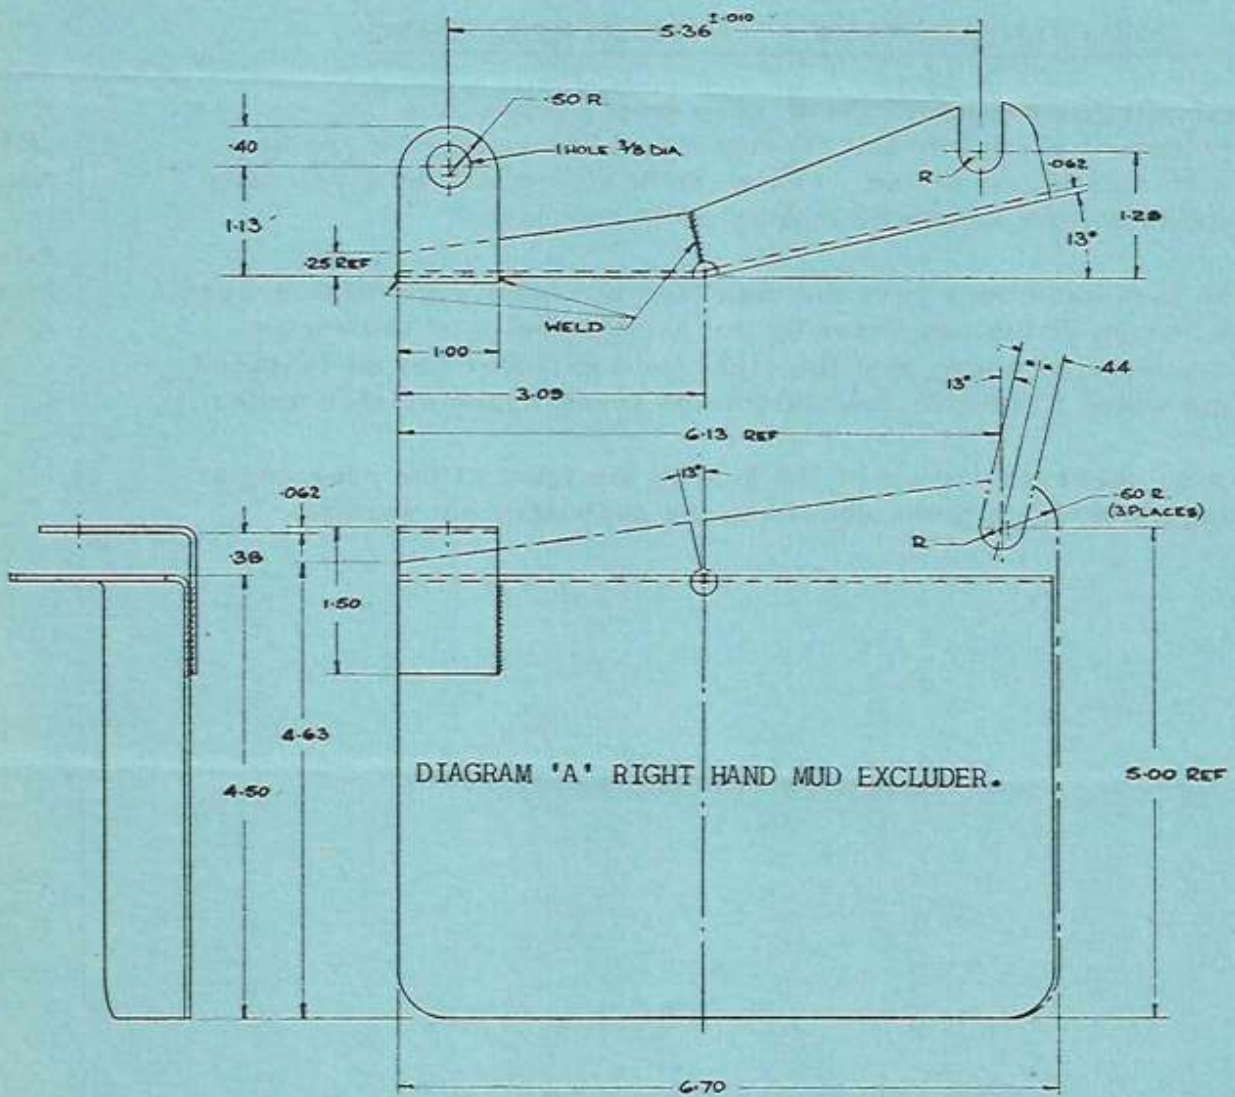
INSIDE BEND RAD. .09

Fit the mud excluders over the right and left hand wire mesh screen at the bottom of the converter by the existing bolts on the engine rear back plate, noting that the right hand excluder has an extended bracket which fits under the bottom set screw of the starter motor.

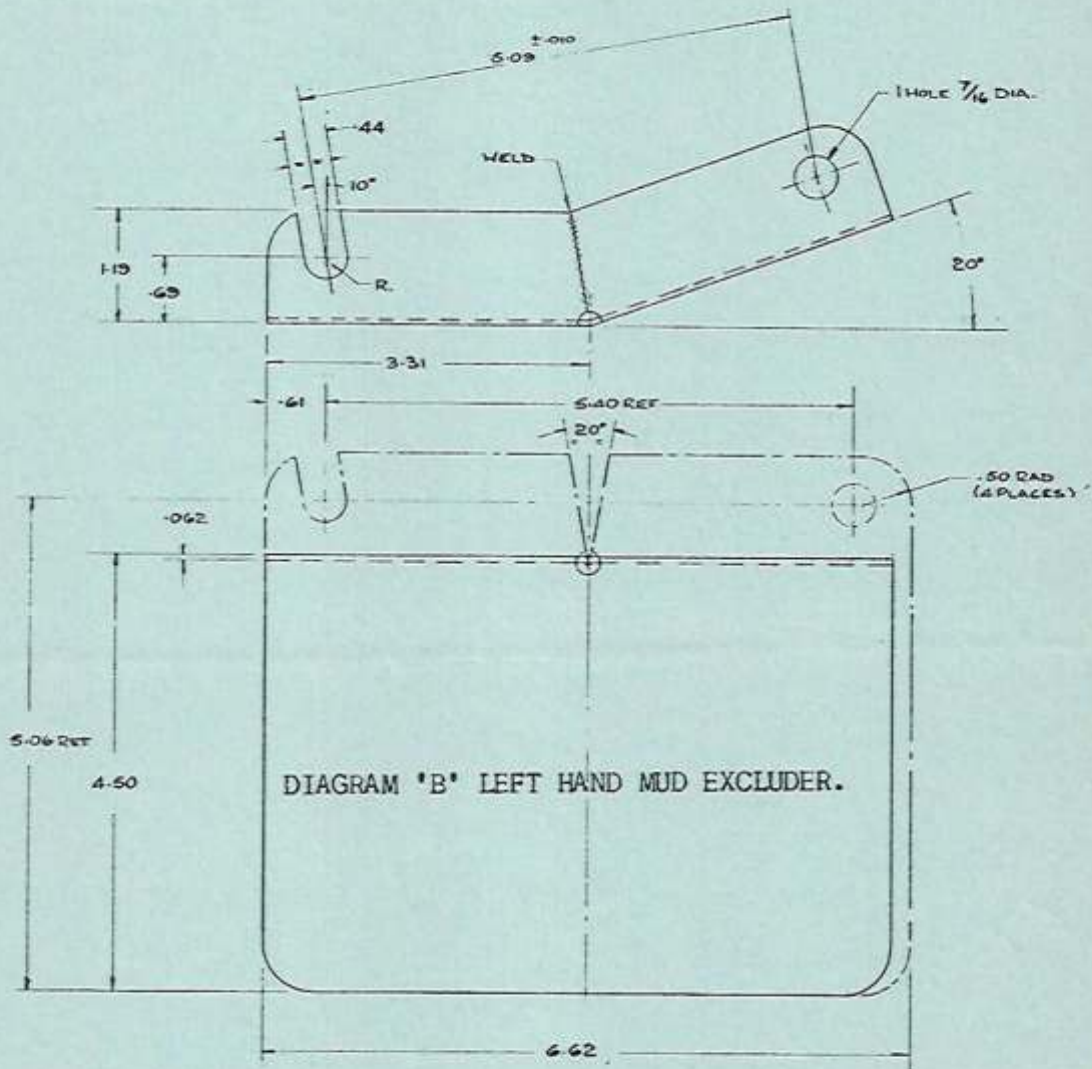
DIAGRAM 'B' LEFT HAND MUD EXCLUDER.

INSIDE BEND RAD. .09
